TECHNICAL SERVICE BULLETIN

BULLETIN NUMBER: D062/D063/D065/D066 – 033 REISSUE ★

SUBJECT: LIGHT IMAGES, TONER DUSTING AND OVER TONING ISSUES

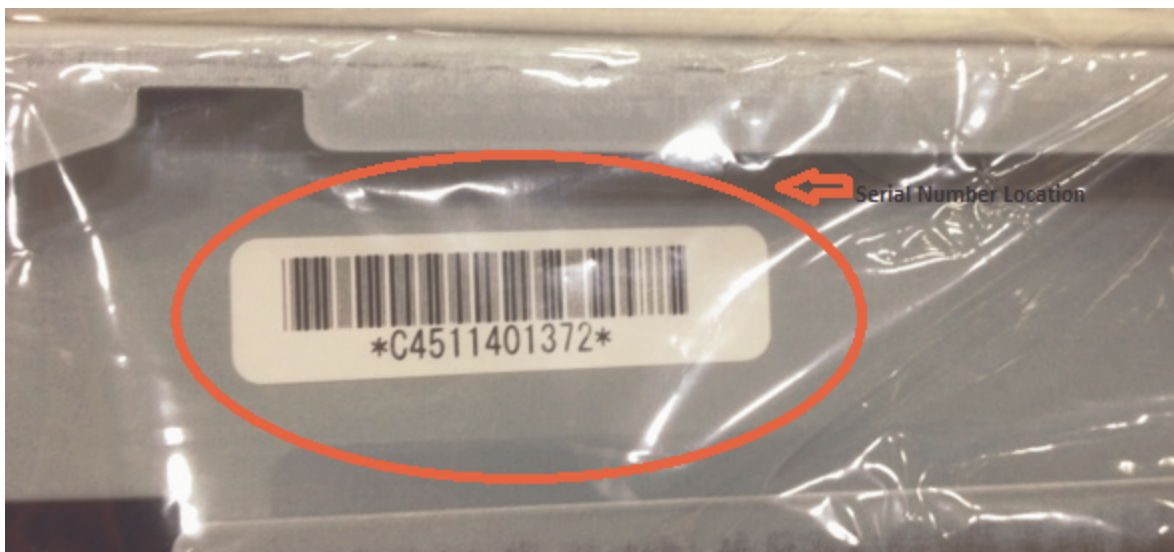
Location of the serial number is show below:

If the above 4 steps do not resolve the issue, replace the Development Unit (P/N - D0623051). We have confirmed the Development Unit serial number starting with C4511304001 or higher has been modified. Consider only the numeric number. Alphabet C is going to remain same.
